## The Sinking of the First Rate *Victory* (1744): A Disaster Waiting to Happen?

Sean A. Kingsley

The sinking of the First Rate, 100-gun English warship the *Victory* on 4 October 1744 was widely attributed to defects in her construction. The era when she was built in Portsmouth dockyard from 1733-37 coincided with a period when the proportions of warships and the leadership of the surveyor general of the navy were severely questioned. Matters came to a head in a series of extraordinary attacks on the establishment in 1744 by Admiral Edward Vernon.

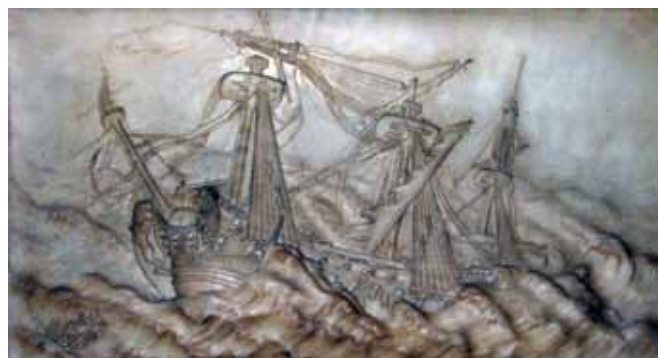
Fig. 1. Detail of the *Victory* sinking on 4 October 1744 on the Balchen Memorial in Westminster Abbey, London.

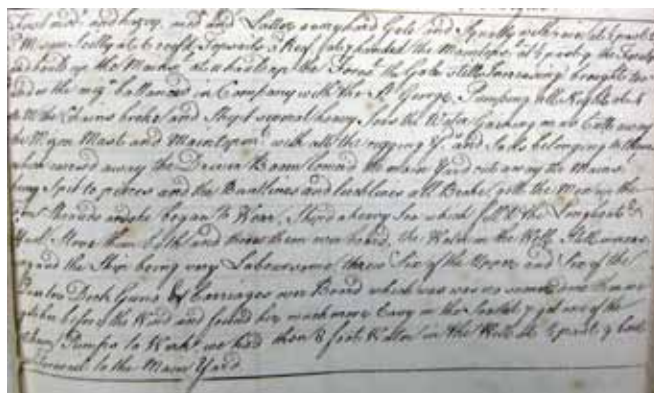
Fig. 3. The captain's log for 3 October 1744 for the Fourth Rate *Exeter* (ADM 51/326) that was almost lost during the storm that sank the *Victory*.

The Fourth Rate *Exeter*, only launched in March 1744 (Winfield, 2007: 126), was the most serious casualty other than the *Victory*. The ship spotted the Scilly Isles at 2.30pm on 3 October, after which the weather turned from moderate and hazy to a very hard gale and squally with rain. On the morning of 4 October (ADM 51/326), the captain logged that (Fig. 3):

Pumping all Night at 4 a:m the Chains broke and Shipt several heavy Seas the Water Gaining on us Cutt away the Mizon Mast and Maintopmt: with all the rigging yds. and Sails belonging to them which carried away the Driver Boom... the main Yard cut away the Mains: being Spit to pieces and the Buntlines and leechlines all Broke, gott the

men up the Fore Shrouds and she began to Wear, Ship'd a heavy Sea which fill'd the Longboat and Yaul, Stove them both and threw them over board, the Water in the Well still increasing and the Ship being very Laboursome, threw Six of the Upper and Six of the Quarter Deck Guns & Carriages over Board which was no sooner done than we got her before the Wind and found her much more Easy in the Sea. at 7 got one of the Chain Pumps to work, we had then 8 foot Water in the Well at ½ past 9.

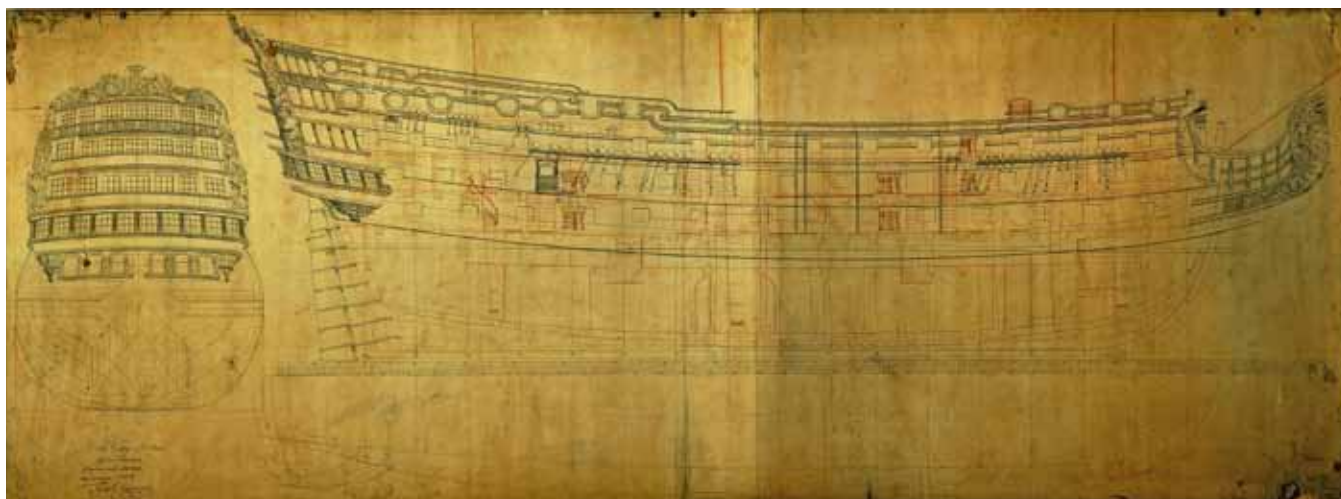
Fig. 4. Plan of the body and stern decoration of the First Rate *Victory* (launched 1737), copied by Frederick Chapman c. 1754. Photo: National Maritime Museum, Greenwich, ZAZ0145.

The escutcheon and taffarel-standards on the *Victory*'s poop-royal formed part of her framework, and unusually elevated the height of the poop 2.52ft higher above the gundeck than on the *Royal-Louis*, a First Rate warship of 124 guns built by Ollivier at Brest. In general, English First Rates of 100 guns were built about 9ft shorter than the French equivalents, such as the *Royal-Louis* and *Foudroyant* of 110 guns. Meanwhile, the French Master Shipwright determined at Woolwich that the 90-gun *Duke* under construction during his visit was scarcely larger than a French ship of 74 guns, was too full at the stern and too slight forward. French vessels were characterized by a great difference in the depth of the hold, ranging from one-eighth to one-tenth deeper than English warships. Ollivier was informed by English shipbuilders that the preference for iron ballast on English warships, in contrast to France, stiffened the hull and counteracted the movements of a ship, especially rolling (Roberts, 1992: 61, 132-33, 135-36, 167).

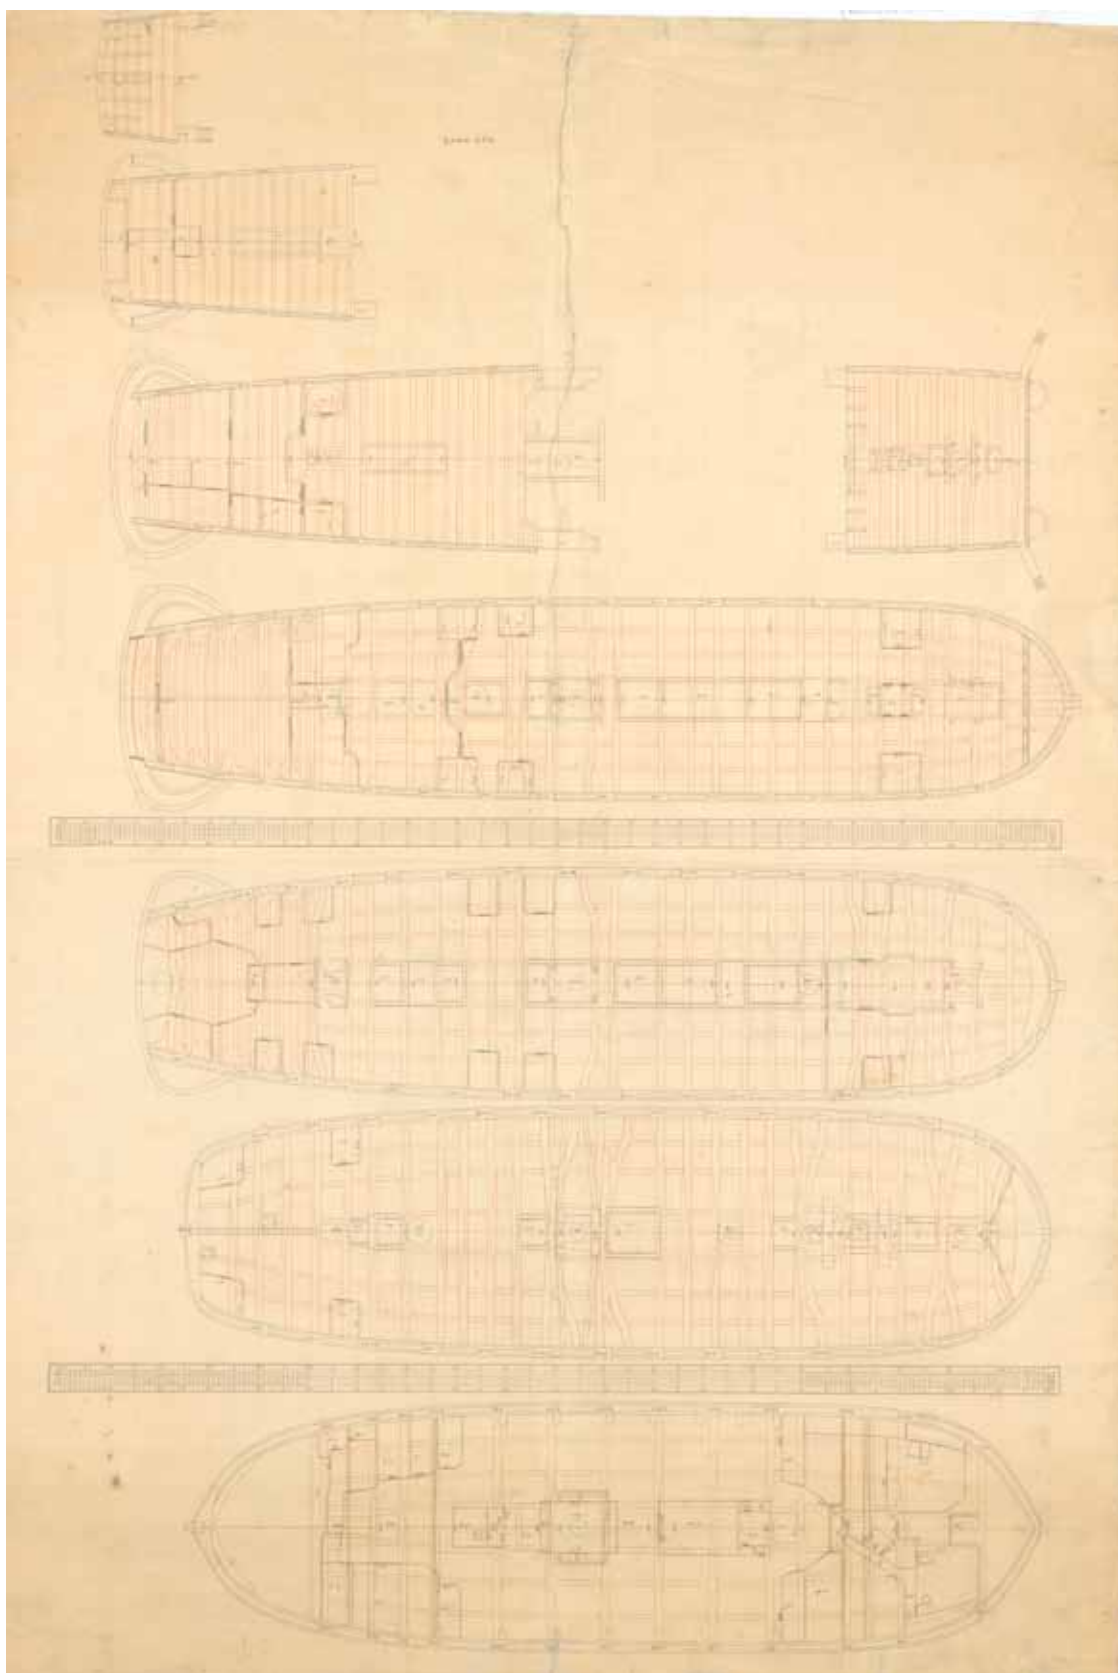
Fig. 5. Plan showing the poop deck, quarterdeck, forecastle, upper deck, middle deck and lower deck of the First Rate Victory (launched 1737). Photo: National Maritime Museum, Greenwich, ZAZ7847.

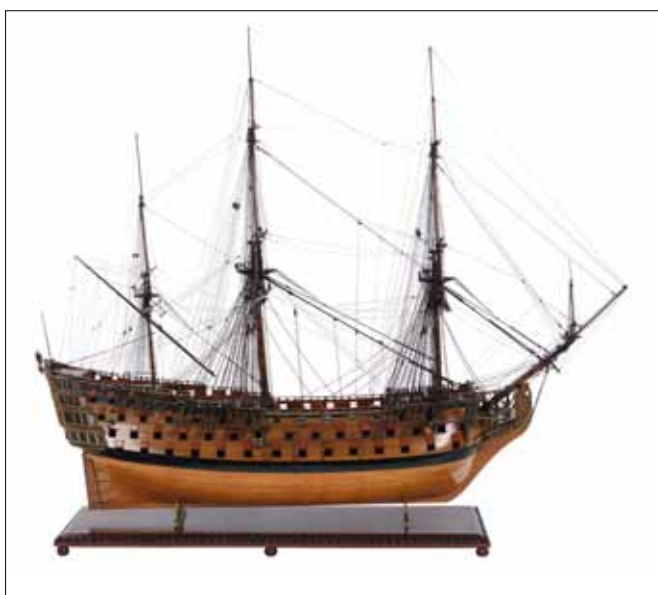
Fig. 6. A contemporary full hull model of the First Rate *Victory* (launched 1737). Photo: National Maritime Museum, Greenwich, SLR0449.

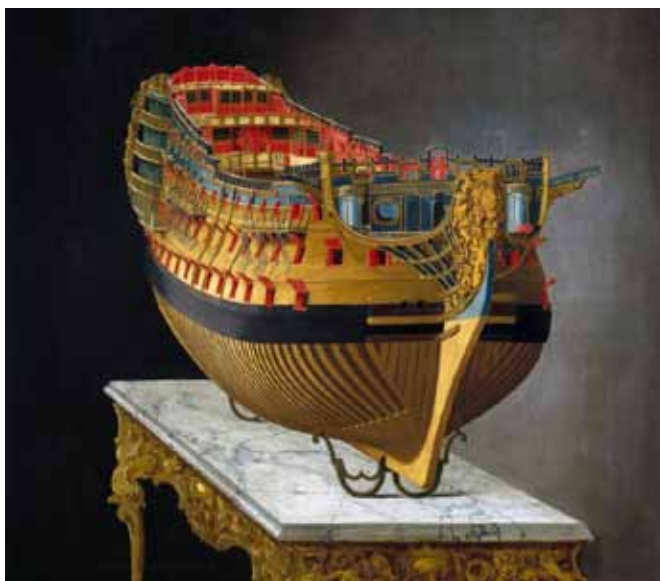
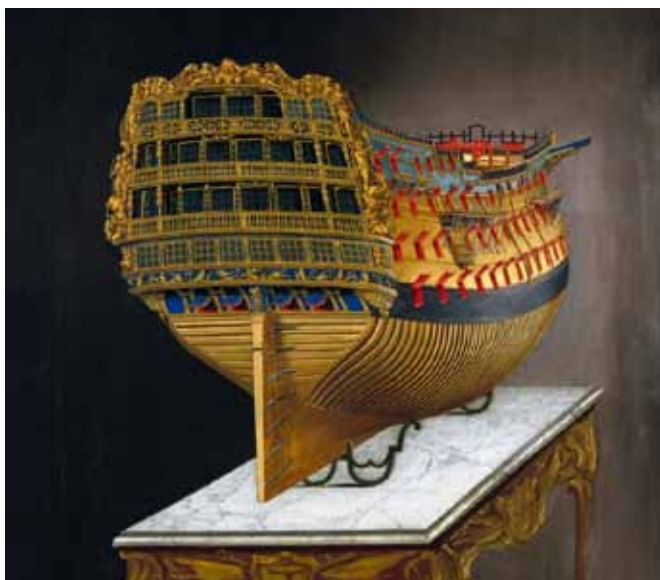
Figs. 7-8. Perspective paintings of a model of the First Rate Victory 1744, formerly in the collection of King George III.  
Photo: Science Museum Group, 1864-12/2.

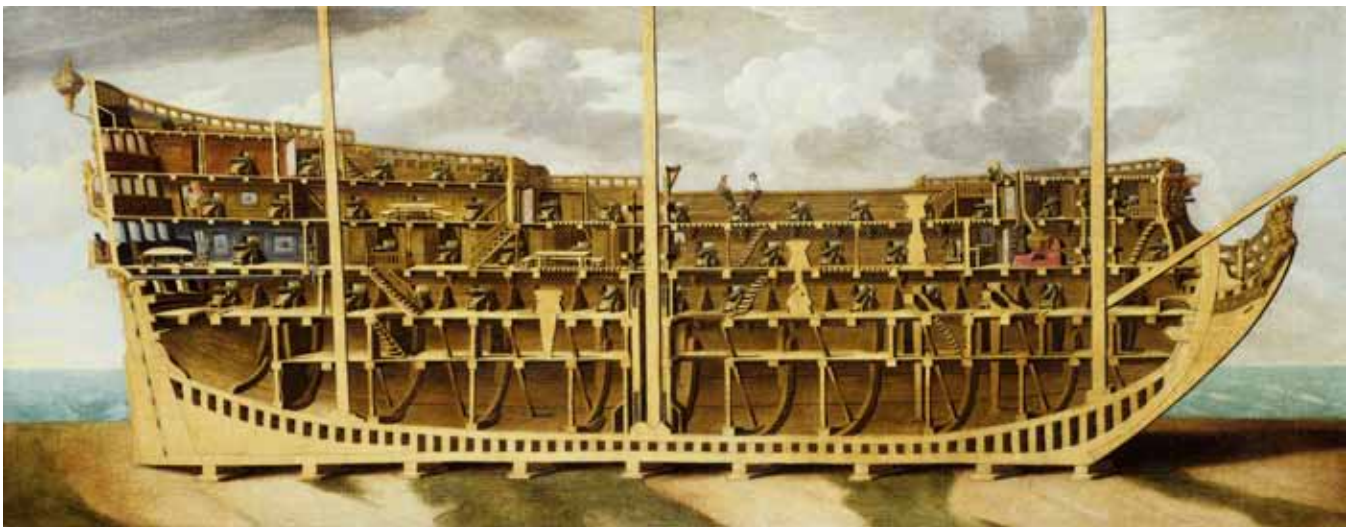
Fig. 13. A cross-section profile of a First Rate English warship by Thomas Phillips, c. 1701. Photo: National Maritime Museum, Greenwich, BHC0872.

The *Victory's* hull may have worked loose at the point where the deck beams took the stress of the masts and joined the side frames. Due to violent laboring and rolling, a ship would then break her sheer and became so twisted and sprung that she lost her design contours (Baugh, 1977: 201). The washing up onto the shores of Guernsey of the *Victory's* mainmast may reinforce such a view (Kingsley, 2015: 5-6), if it was not cut down deliberately. Incapable of holding the wind, and with the elements buffeting her unusually elevated stern, the greatest warship of the Early Georgian era rolled over into the ocean, turning 180°, and vanished beneath the waves (Newman, 2015). She settled with the bows to the northeast and the stern to the southwest (Seiffert *et al.*, 2013: 10-12).
