An Iron Cannon Salvaged from the *Marquise de Tourny*, Western English Channel

Nico Brinck

Ordnance Specialist, Terschelling, Netherlands

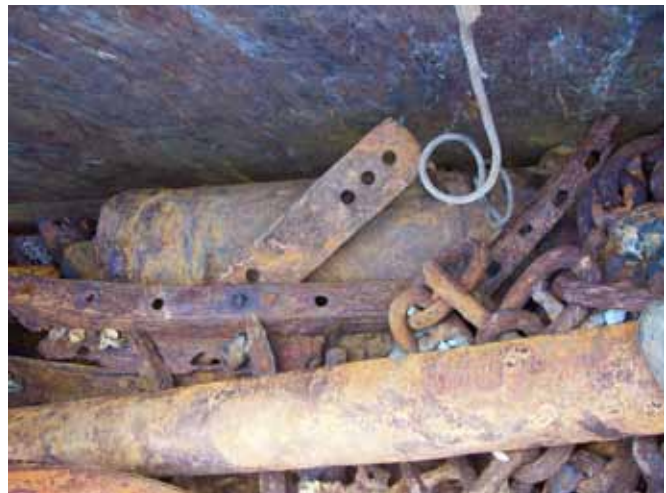
Fig. 1. The iron cannon discarded in a salvage yard dump. Photo: Nico Brinck.

The author was recently made aware of an iron cannon salvaged from a wreck believed to be the *Marquise de Tourny*, a French privateer built in 1744 and lost in the late 1740s or early 1750s in the Western English Channel (Cunningham Dobson, 2011). The gun was made available for recording (Fig. 1). The cannon can be identified as an 8-pounder on the basis of its 10.5cm-diameter bore. It was missing its trunnions and muzzle. Further minor damage was visible. Simple ornamental rings divide the cannon into three parts: breech and first reinforce, second reinforce, and chase (Fig. 2). On the first reinforce an astragal ring with fillets marks the end of the vent field, and a similar set of rings is positioned on the neck between the muzzle and the chase (Fig. 3). A notable reduction of thickness was measured at the reinforces. Except two *fleurs de lys* located at the beginning of the first reinforce and three-quarters of the way along the second reinforce, no further marks were identified (Figs. 7-8).

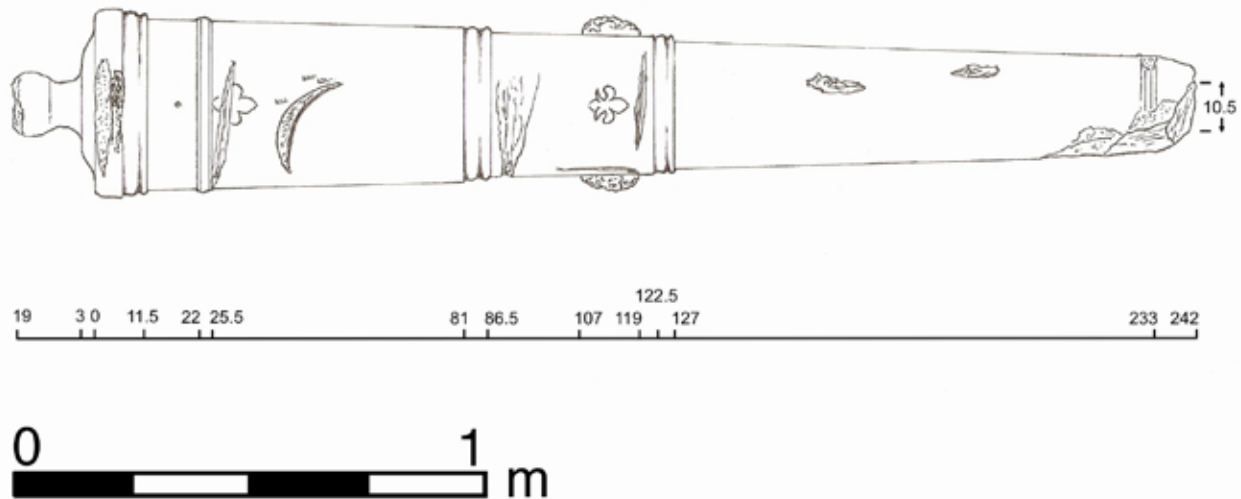
Iron 8 Pounder (7'10" French)

Fig. 2. The iron cannon discarded in a salvage yard dump. Length measurements in cm. Photo: Nico Brinck.

The key preserved dimensions are (Fig. 2):

- Breech: 19cm
- Barrel (forward of the breech): 242cm
- Th. at the vent field: 37cm
- Th. at the muzzle astragal: 21.5cm
- Bore Diam. 10.5 cm

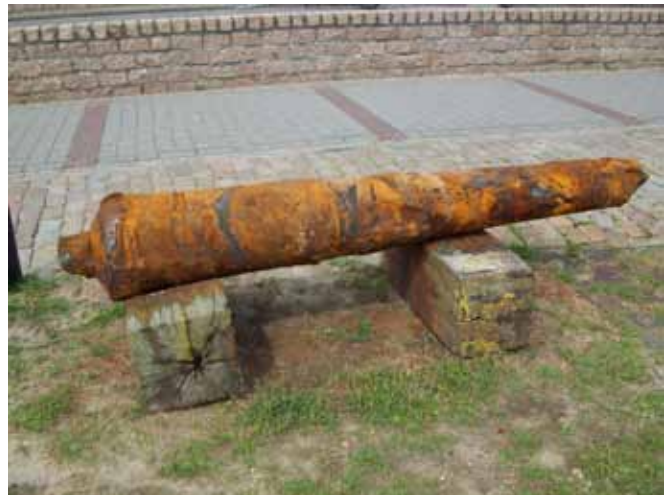
Fig. 3. Full-length view of La Marquise de Tourny's salvaged 8-pounder. Photo: Nico Brinck.

All thickness measurements of the salvaged 8-pounder adhere to these regulations, and the center of the trunnions differs by only a few centimetres from the standard. Further, this piece exhibits two *fleurs de lys*. A third one was probably originally engraved onto the muzzle swell, but the gun is broken at this point so that about 15cm of the muzzle is missing.

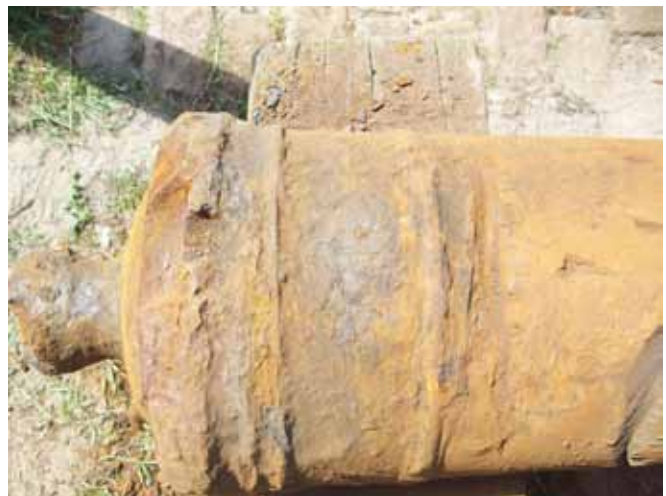
Fig. 4. Detail of the cascable and button of the salvaged 8-pounder. Photo: Nico Brinck.

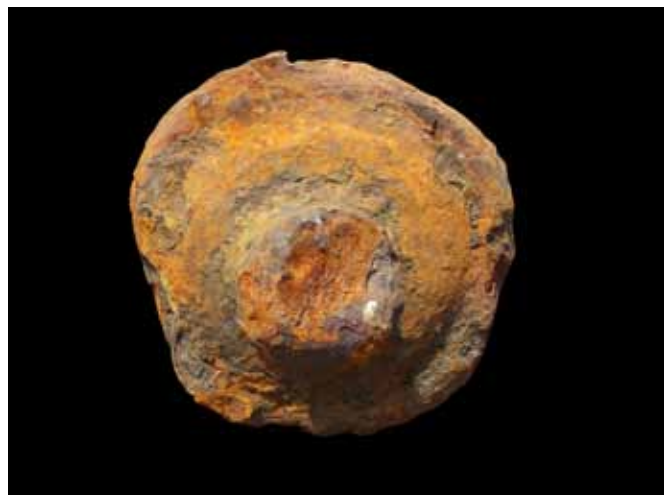
Fig. 5. Detail of the cascable and button of the salvaged 8-pounder. Photo: Nico Brinck.

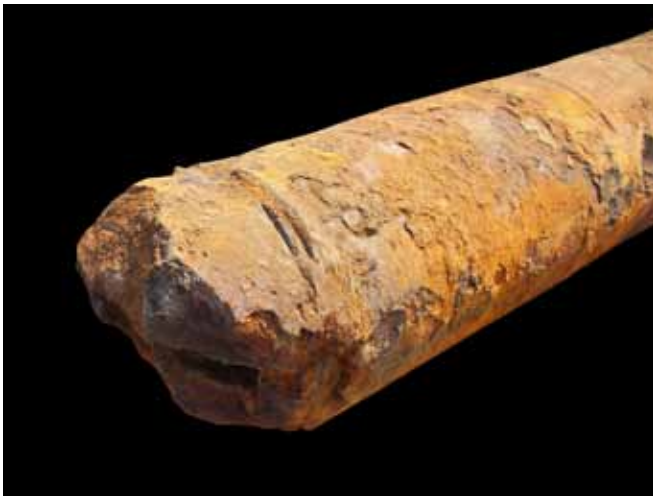
Fig. 6. Detail of the broken bore of the salvaged 8-pounder. Photo: Nico Brinck.

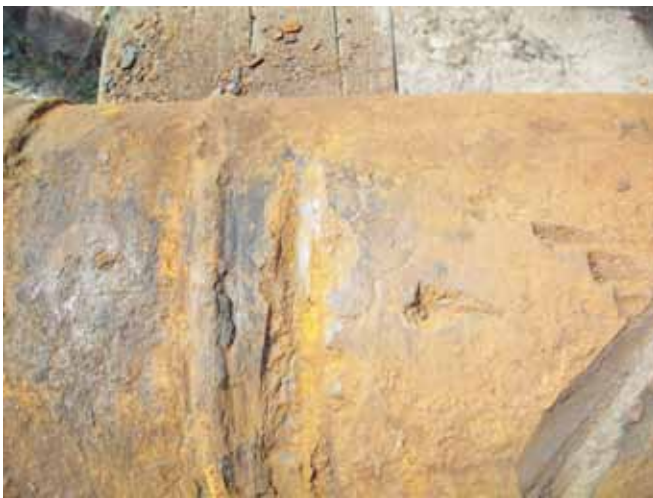
Fig. 7. Detail of a fleur de lys on the first reinforce. Photo: Nico Brinck.

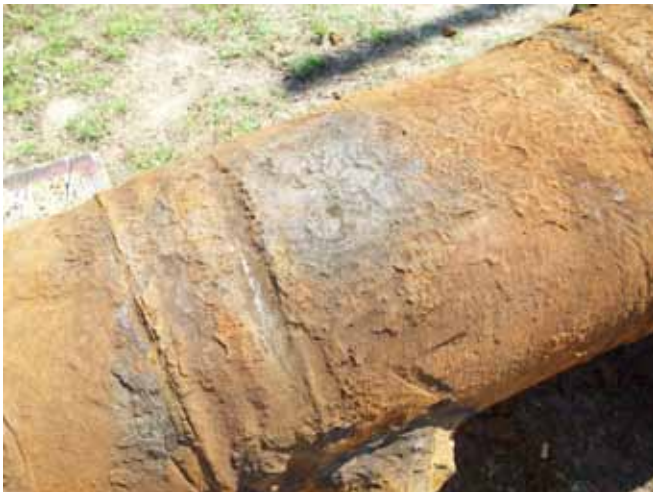
Fig. 8. Detail of a fleur de lys on the second reinforce. Photo: Nico Brinck.

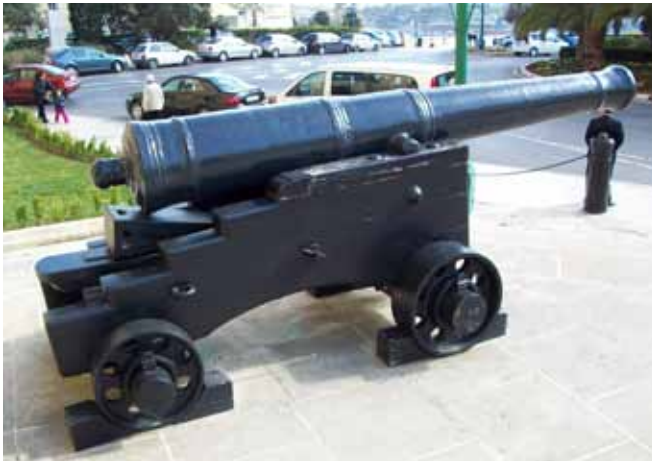
Fig. 9. An 8-pounder French iron cannon at Valletta, Malta, of the salvaged Marquise de Tourny form. Photo: Nico Brinck.

A French 8-pounder is known from Valletta, Malta, however, where it stands in front of the Auberge de Castilia, and exhibits almost the same dimensions and shape as the gun from the English Channel (Fig. 9). The rings and trunnions are all set in the same place, its trunnions are still

conical and the length is 258.5cm, which may also have been the length of the gun in question. Regulations preferred a length of 256cm for an 8-pounder, which is close to the length of the Valletta gun. After 1766 the regulations demanded shorter guns for the navy and trunnions were always straight cylinders. Thus, the English Channel cannon and the Valletta piece both date to the earlier half of the 18th century. The Channel 8-pounder fits very comfortably with the timeframe of the privateering actions of the *Marquise de Tourny* (Cunningham Dobson, 2011: 98-101).
